BROCHURE

YADi Quick Response Center

REPAIR CASE

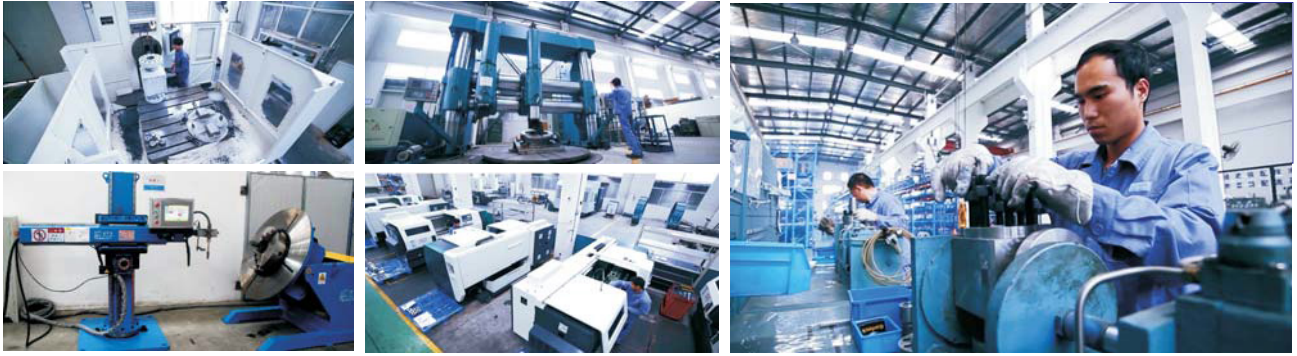
Superior Manufacturing Conditions

YADi has a complete set of machining, welding, hard surface treatment, heat treatment and testing equipment for manufacturing of control valves. It is famous for its superb process and machining level, and able to complete high-quality machining involved in control valve maintenance.

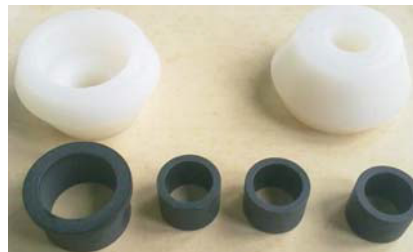
Seal Inventory

Seals of general specifications, such as the packing, wound gaskets, graphite gasket and O-ring, are available in the inventory. YADi is also able to manufacture special seals such as C-rings, metal O-rings, self-sealing graphite rings and balanced seals.

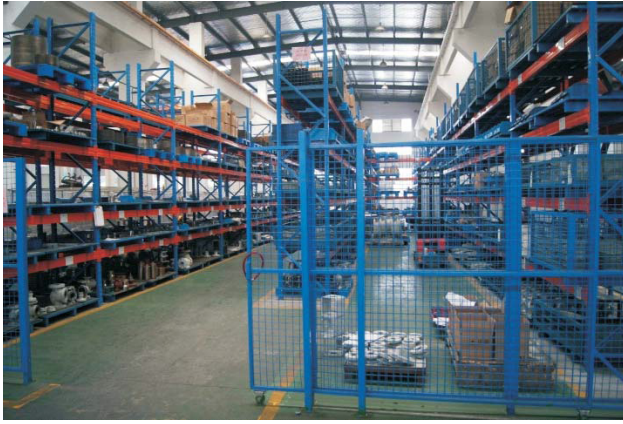
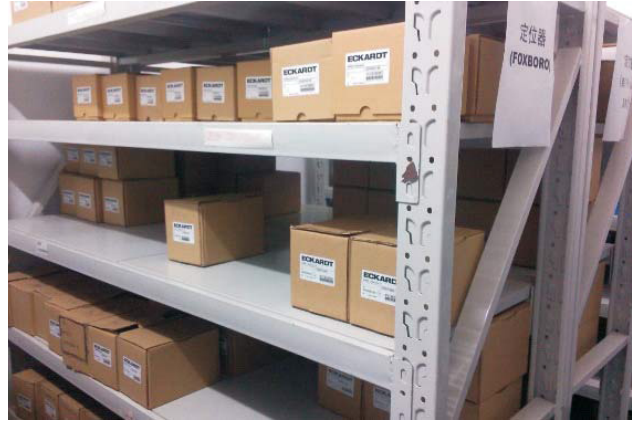
Accessory Inventory

Positioner, solenoid valves and gas-controlled accessories are available in the inventory.

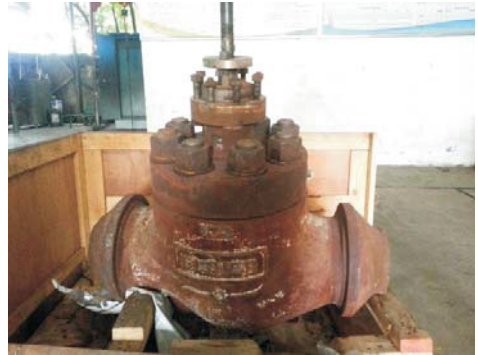
Client: Sinopec Zhenhai Refining & Chemical Company
Installation section: boiler blow-down section of 4th power station
Process parameters: high-pressure steam of 13.1MPa and 540°C
Valve information: start exhaust valve of DN150, Class2500, WC9, manufactured in 2009

Fault

1. Serious leakage occurred inside the valve.
2. The flow could not be controlled when the small opening controller sends a signal.

The stem part exposed to the packing was damaged as a result of strain.

The C-ring was worn or broken.

The valve seat was subject to through type cracking.

The periphery of the sleeve was subject to non-through type cracking.

The original valve trim was damaged seriously, so the causes were analyzed. Such damage was mainly caused by vibration under medium impact and dramatic temperature change in startup and shutdown during long-term operation. If the valve trim was repaired without structural change, similar problems would still occur in a period. Therefore, the valve structure was upgraded into a pilot type structure with large and small elements (as shown on the right). This not only guarantees Class VI leakage, but also makes the small opening controllable. At the same time, the whole set of seals were replaced.

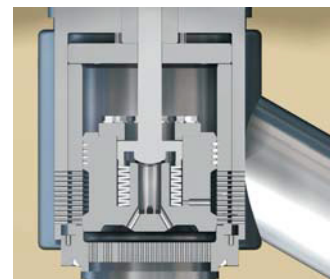
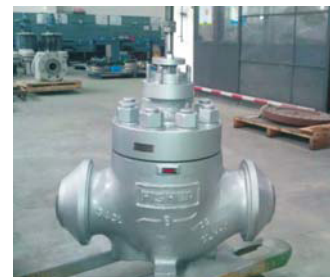
The repaired valve was put into use in November 2013. Up to now, it has been running steadily according to the site requirements, without internal leakage.

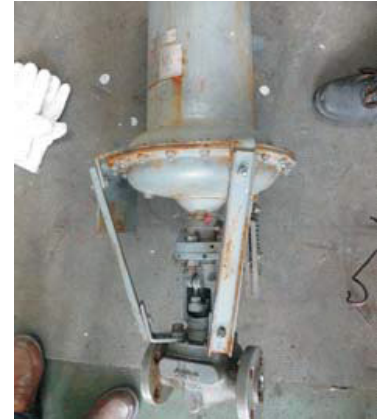
Valve information: track ball valve of DN25, Class300 and CF8M, manufactured in February 2013

Fault

1. The valve was stuck in the small opening position and produced abnormal sound when opened.
2. The serious leakage occurred inside the valve in the fully closed position, up to 5000ml/min.

The sealing surface of the ball was damaged seriously.

The stem surface was worn seriously.

The end of guide pin was worn or the guide slot of the stem was deformed.

The sealing surface of the seat was scratched.

The amount of valve trim expansion after heating was calculated, and the gap between two seals was controlled until the valve was not stuck. The stem, dowel pin or seat is damaged seriously, so they were manufactured again with Inconel alloy. Surfacing with stellite was conducted on the scratched part of the surface of the valve element, followed by grinding repair.

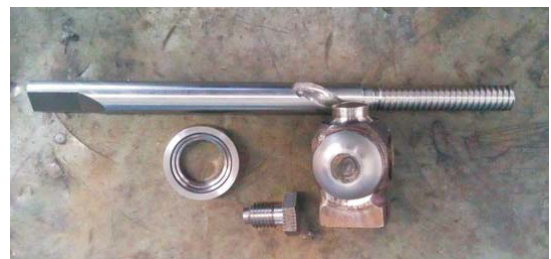
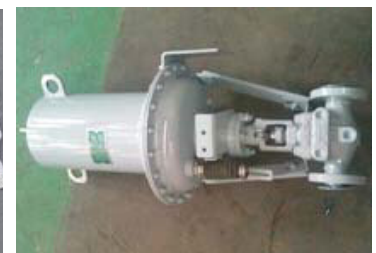
Parts were remanufactured or repaired according to high quality requirements. The self-made low-temperature devices that are light and reliable were used, so disassembly was finished in 5 minutes. The valve was put into use in December 2014. Up to now, it has been running reliably according to the site requirements, with little leakage.

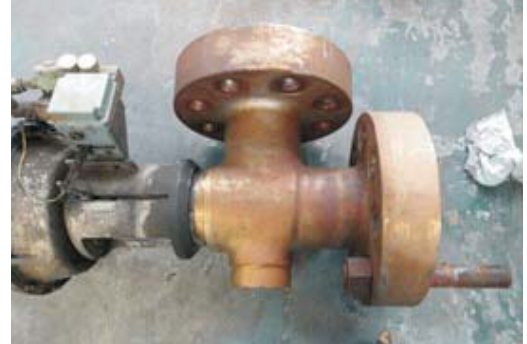
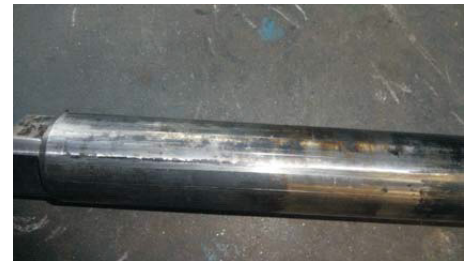
Valve information: high-pressure angle valve of DN150, Class2500 and CF8M, manufactured in January 2004

1. The valve packing leakage did not meet the standard.
2. The small opening could not be adjusted.

The sealing surface of the valve element was subject to serious cavitation and corrosion.

The sleeve was subject to serious cavitation or completely damaged.

The stem part exposed to the packing was damaged as a result of strain.

The valve opening was always 20% to 30% on the site, which accelerated erosion of valve trim. Therefore, the opening was adjusted to 40% to 50% for normal operation, by surveying the original size of valve trim, calculating the rated Cv value for opening reduction, and adding the diversion spacer, in order to reduce medium erosion to the valve trim.

The original valve trim was made of 440C. According to the characteristics of hydrocracking unit, the medium contains a small amount of H₂S, which is corrosive. Therefore, the trim material was upgraded into Ni50, to extend the valve life.
